**CRYOGENIC GLASS-FILAMENT-WOUND
TANK EVALUATION**

**STRUCTURAL COMPOSITES INDUSTRIES, INC.
for
AEROJET-GENERAL CORPORATION**

NASA Lewis Research Center
Contract NAS 3-10289
James R. Barber, Project Manager

FINAL REPORT

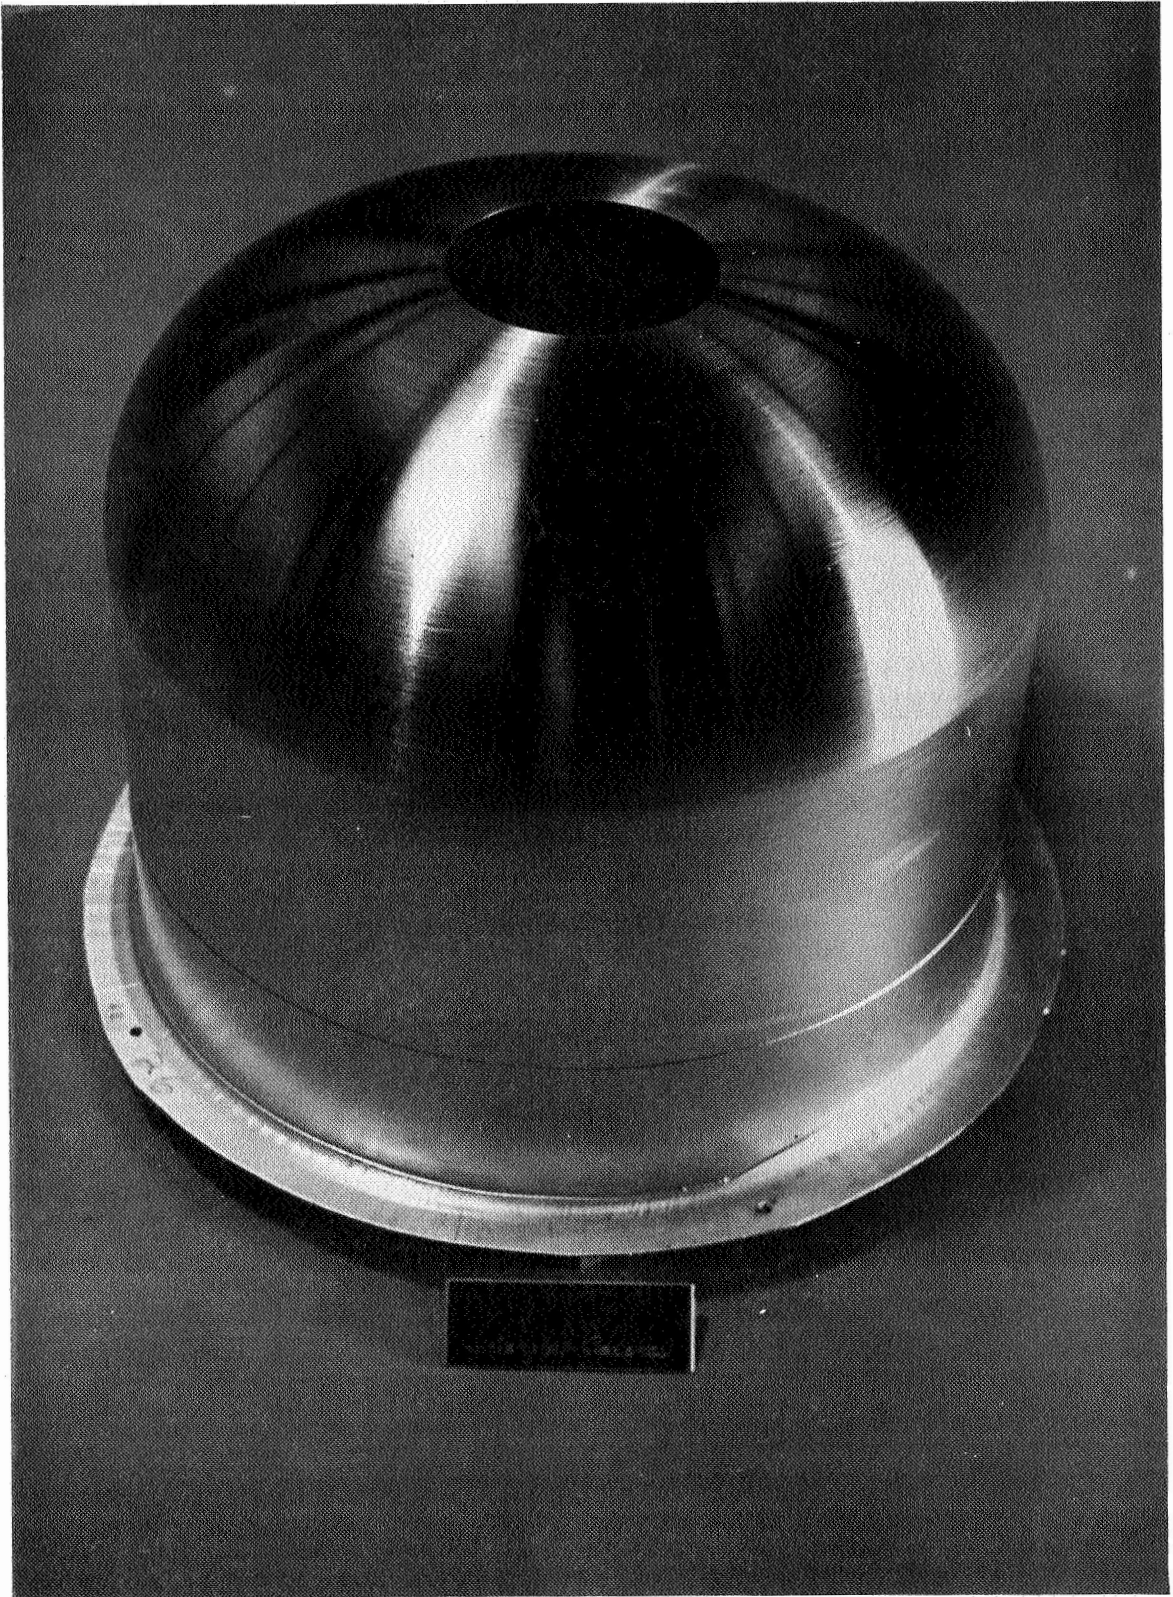
Figure 30

Drawn and Machined 1100 Aluminum Halfshell Forming for Hinged Boss Liner

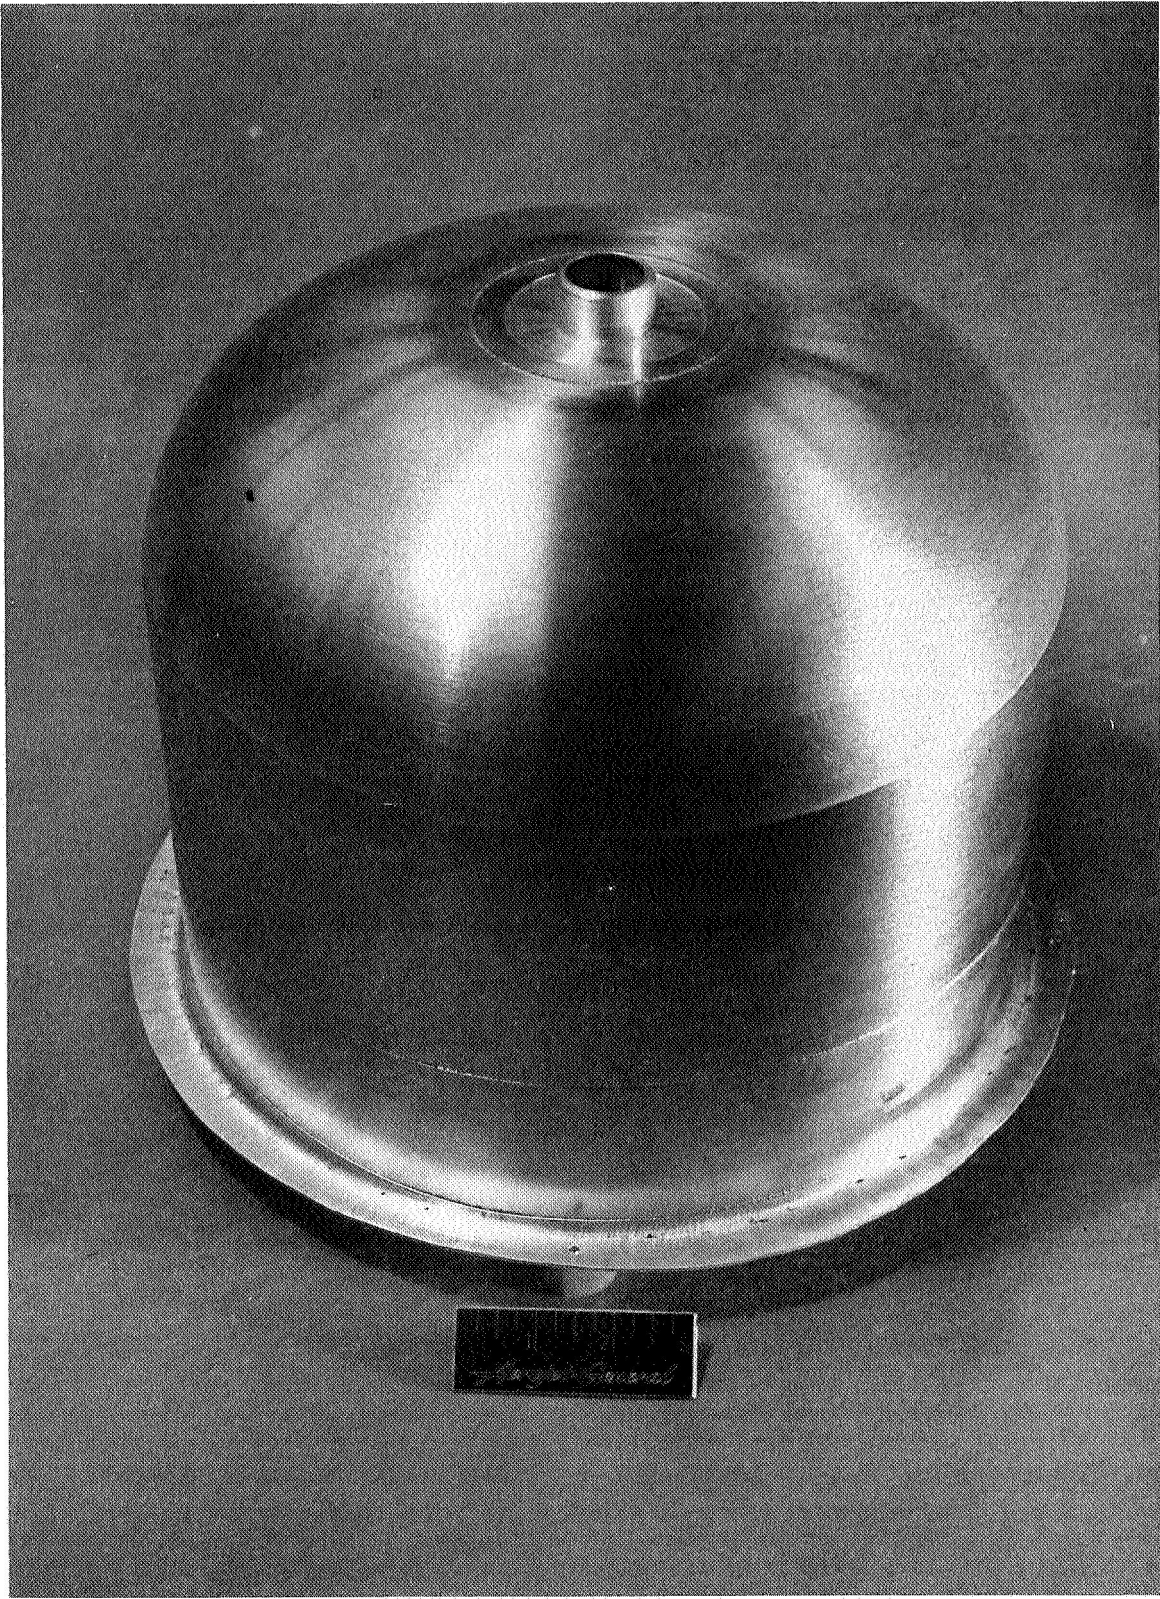
Figure 33

Flange Welded to Drawn and Machined Halfshell Forming for Hinged Boss Liner

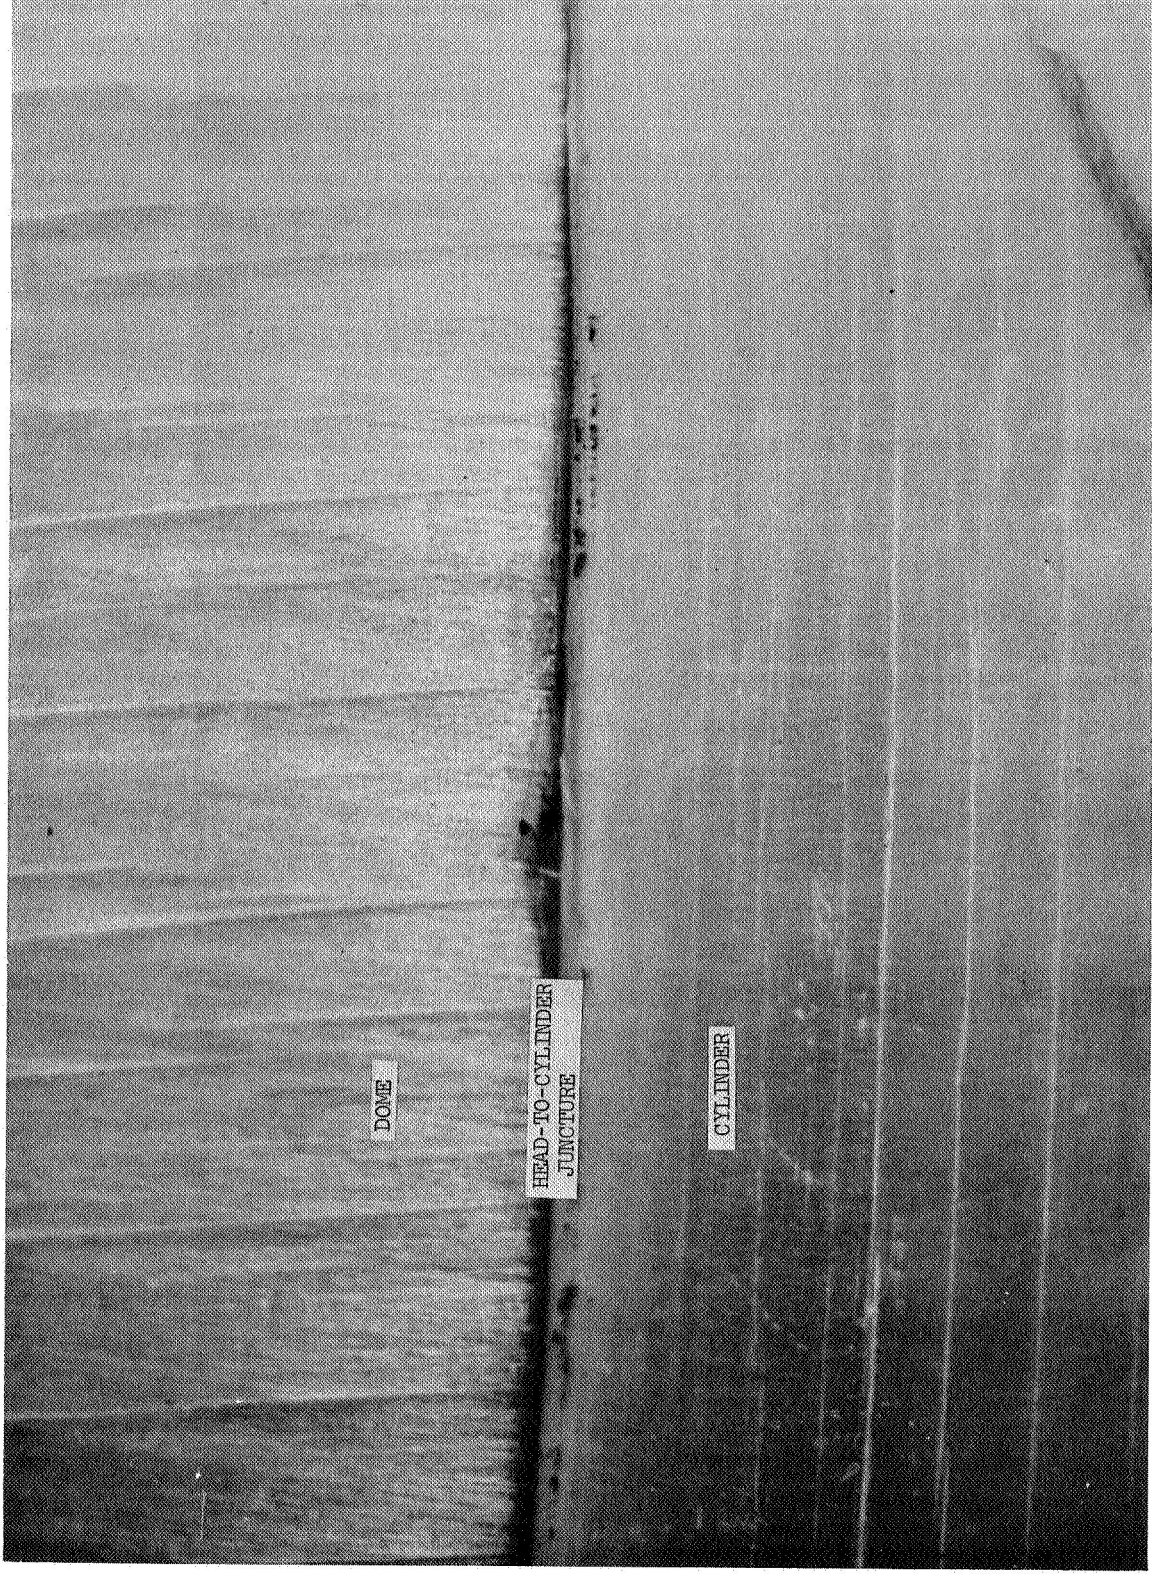
Figure 114
Outside View of Tank A-13 Head-To-Cylinder Juncture,
Showing Filament-Wound Composite Craze Cracking
